Contents

Introduction

This audit covers the area bounded by Martin Luther King Jr. Boulevard, on the east by Trinity Street, on the south by 10th Street, and on the west by Lavaca Street. Outlying buildings include the William P. Clements Building located at 300 West 15th Street and the Ernest O. Thompson Building located at 920 Colorado Street.

Capitol Grounds South of 15th Street

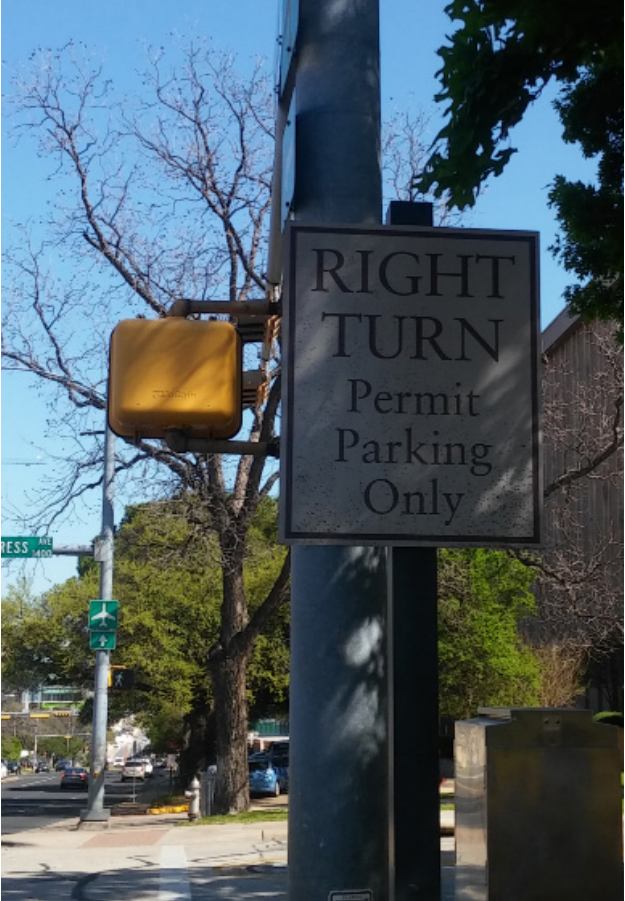
7 Signs lack visibility due to placement and shade from landscaping.

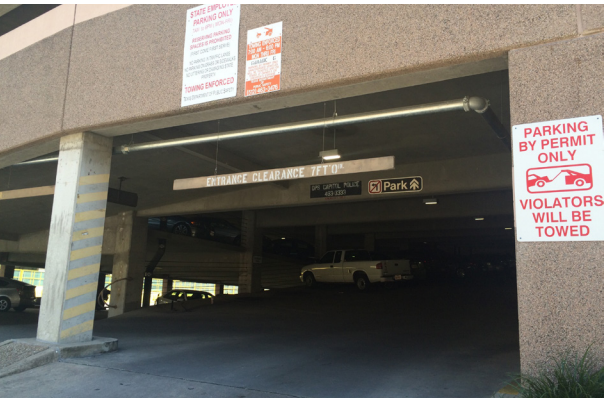
Some clearance bars are built with low quality wood and are deteriorating.

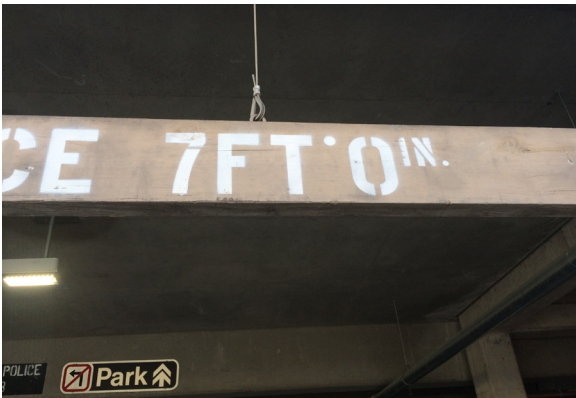
Clearance bar graphics are faded and messages are inconsistent and do not use proper inch and foot marks.

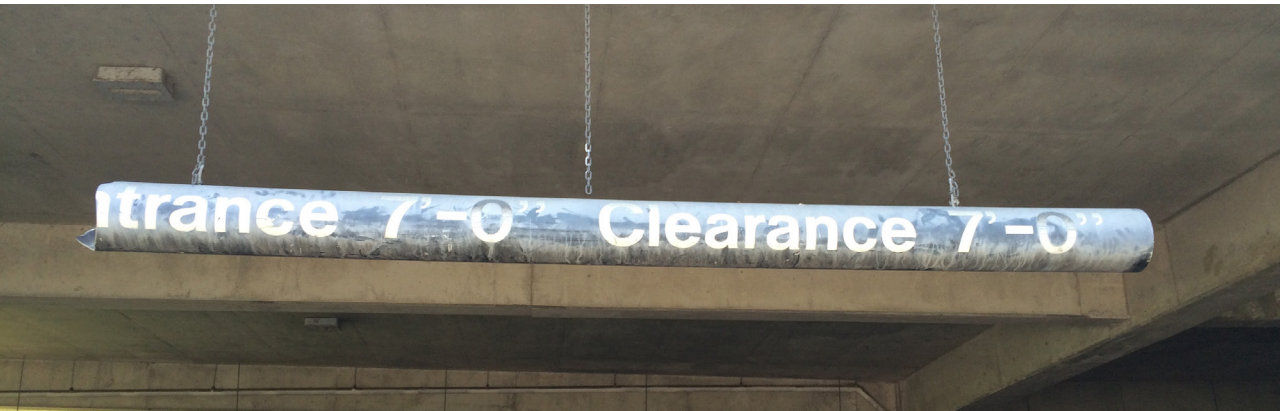
5 Clearance bars are damaged and are no longer informative to the user.

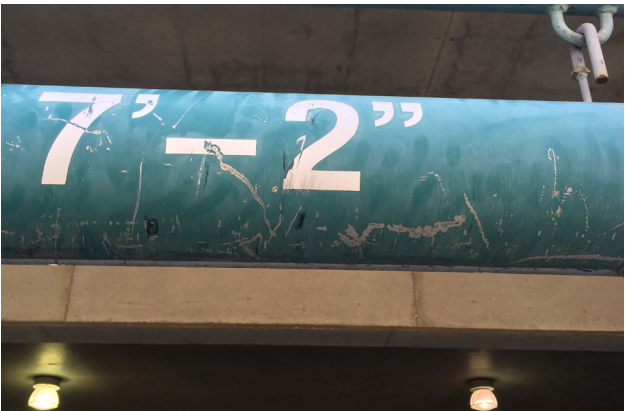
5 Clearance bars are damaged and messages do not contain proper inch and foot marks.

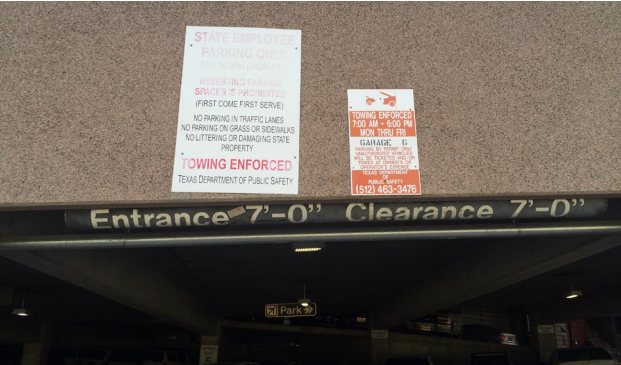
Regulatory signage and clearance bar information vary in placement and visibility.

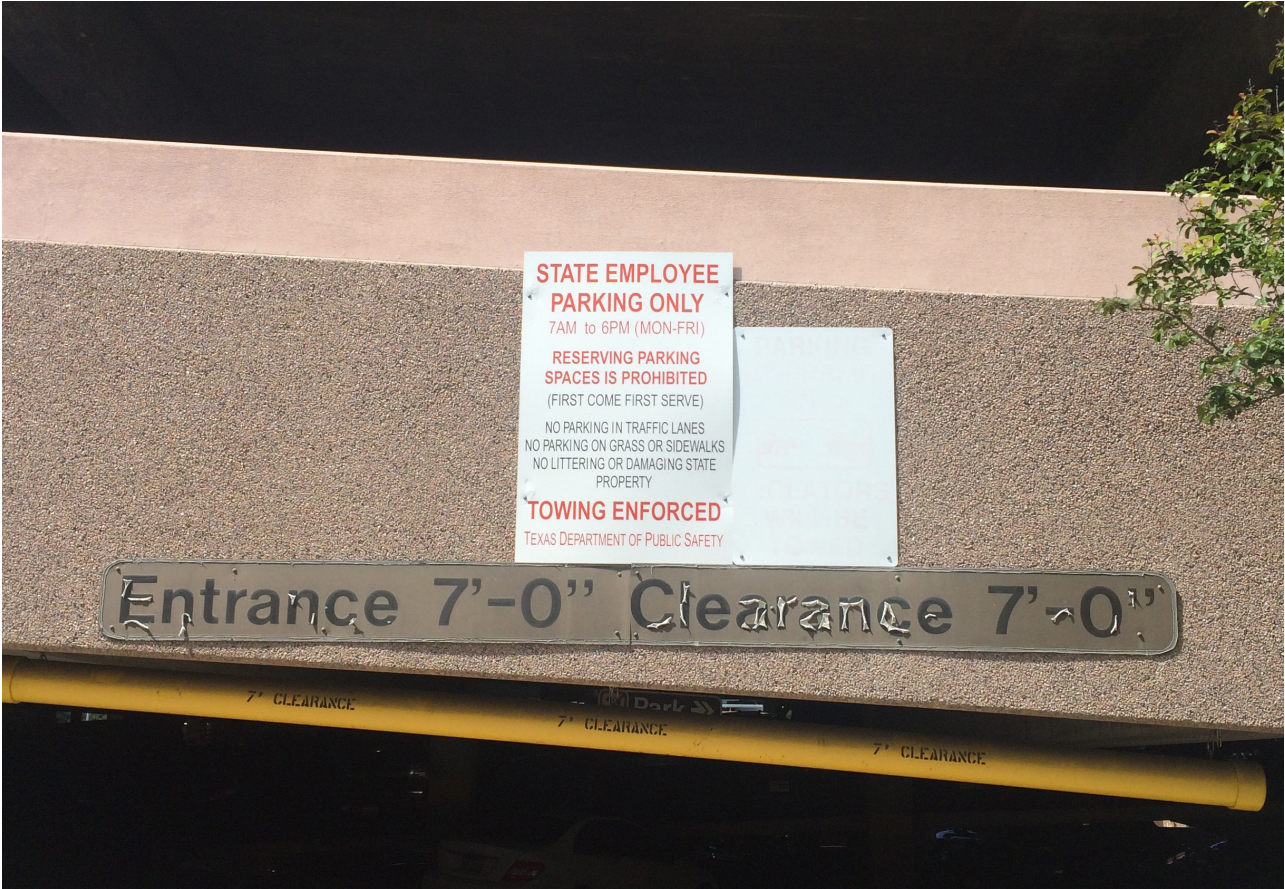
Regulatory signs are faded and no longer visible to the user. Clearance bar information is repetitive and varies in message and appearance.

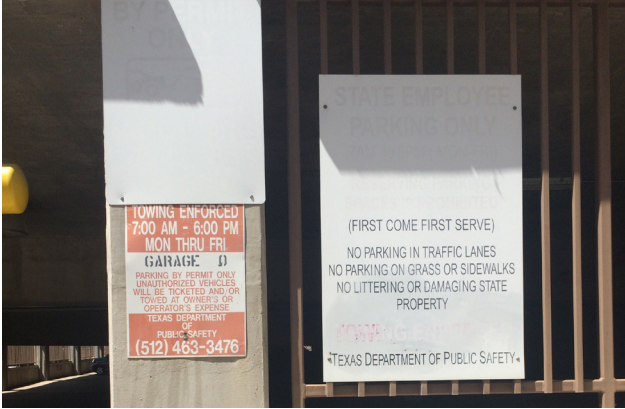
Many Regulatory signs are no longer functional to the user due to deterioration.

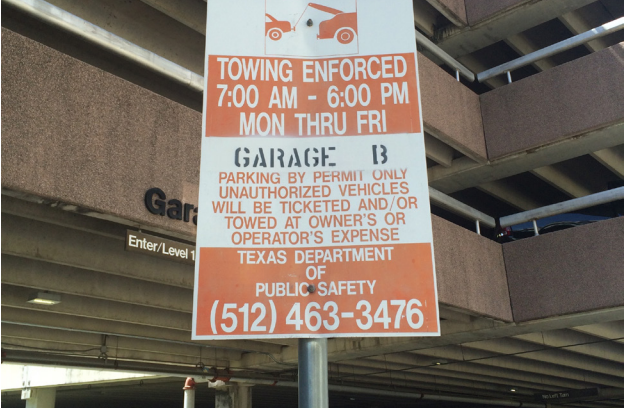
5 Regulatory information varies in placement. Existing signage is located both on buildings and exterior freestanding poles.
